THE MECHANICAL RESISTANCE OF SATURATED STONES

Paola Marini¹, Rossana Bellopede¹

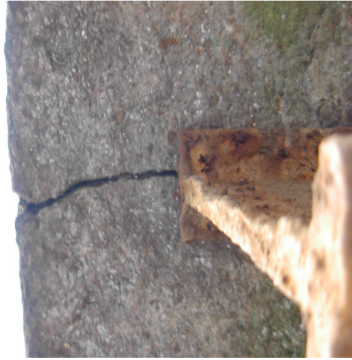
Figure 3: Details of a balcony where the beam leans in correspondence to a fracture.
